Crooked Lake Monitoring Study

STEUBEN COUNTY, INDIANA

May 26, 2003

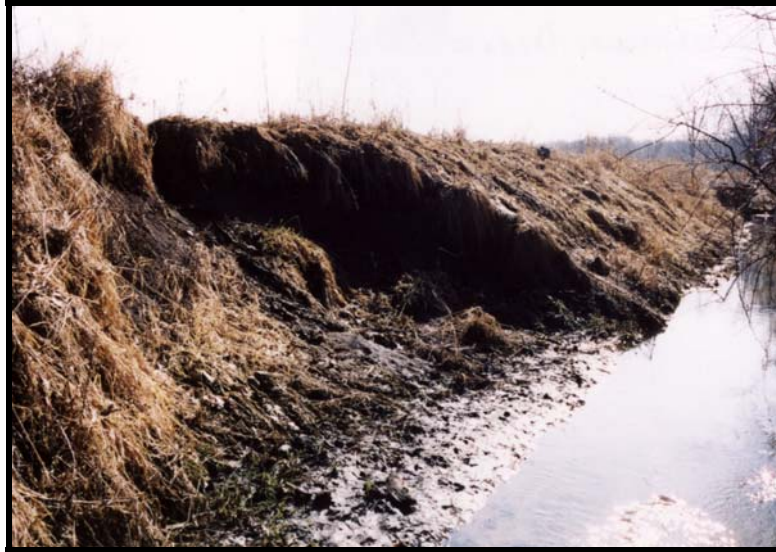
Figure 11. Sediment deposition and streambank erosion observed along Palfreyman Drain at site P8.

Site	Identified Concern	Potential Management Practice
P1	Road drainage/litter	Re-route water from road drainage into vegetated swale; initiate roadside litter clean-up program along tributaries
P2	Pipe draining county highway facility; truck in parking lot leaking petroleum based substance to drain	Work with the county highway department to address storage of materials and vehicle; route parking lot drainage through vegetated swale or off-line detention
P3	Road drainage/litter	Re-route water from road drainage into vegetated swale; initiate roadside litter clean-up program along tributaries
P4	Field is farmed to stream edge	Utilize conservation tillage and/or install filter strips
P5	Streambank erosion	Feasibility/design project*
P6	I-69 drainage pipe	Explore filtering options
P7	Sediment deposition along stream bed	Feasibility/design project*
P8	Streambank erosion (Figure 11)	Feasibility/design project*

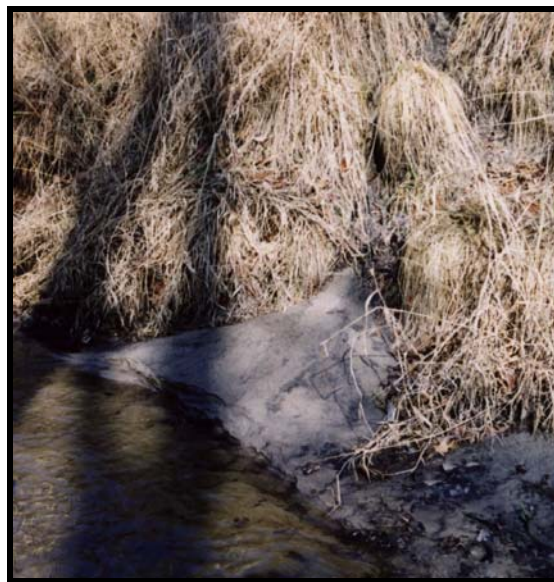
Figure 12. Site P12 showing streambank erosion along Palfreyman Drain.

P9	Field is farmed to stream edge	Utilize conservation tillage and/or install filter strips
P10	Residential area drainage pipe	Explore filtering options
P11	Sediment deposition along stream bed	Feasibility/design project*
P12	Streambank erosion (Figure 12)	Feasibility/design project*

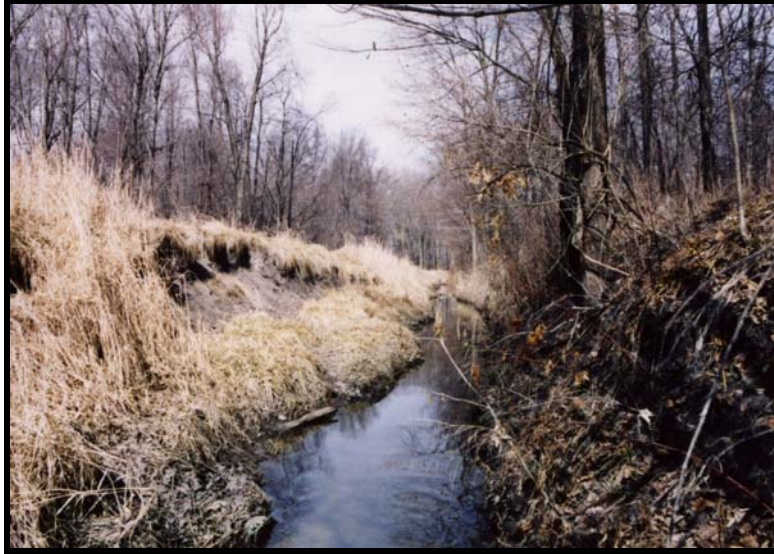
Figure 13. Site P16 showing sloughing banks along Palfreyman Drain.

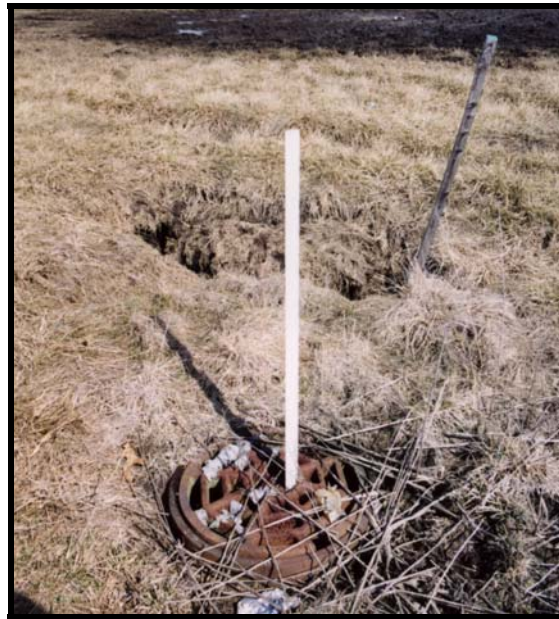
Figure 14. Water by-pass of existing stormwater infrastructure observed at Site P33.

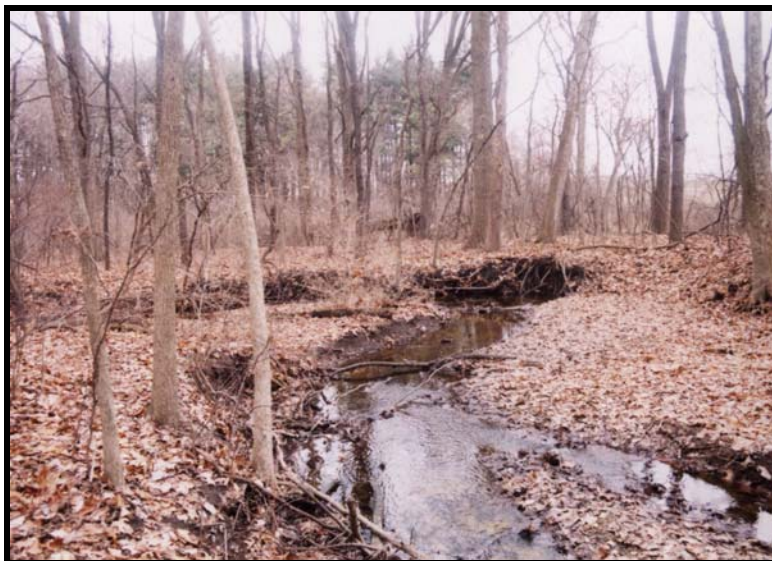
Figure 15. Site C1 showing streambank erosion along Carpenter Drain near the outlet to Crooked Lake.

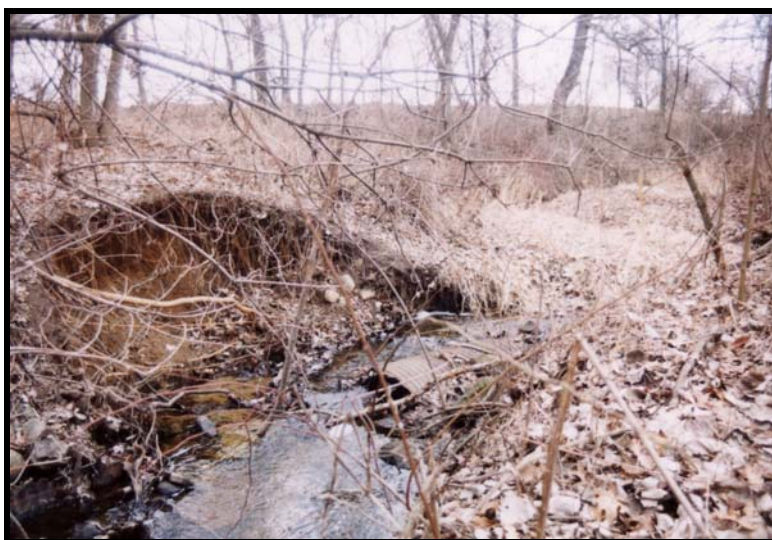
Figure 16. Site C2 showing an old drainage pipe causing water deflection which results in streambank erosion and bank sloughing along Carpenter Drain.

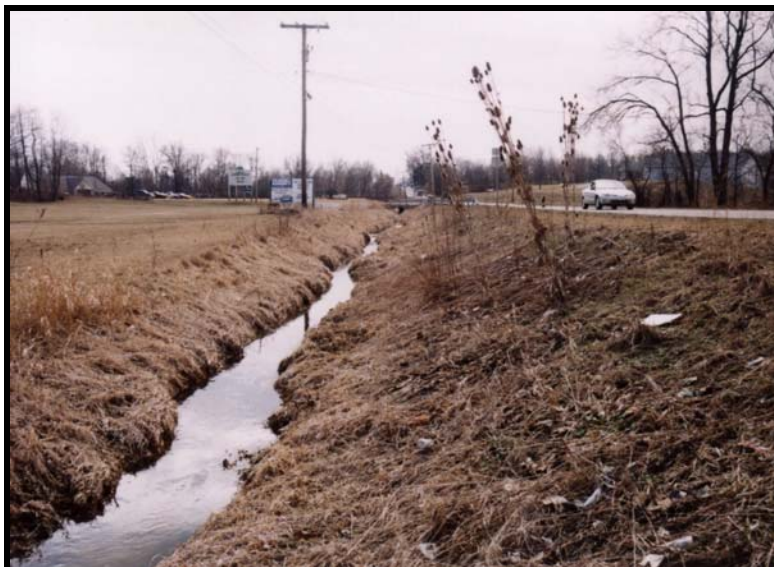
Figure 17. Site C4 showing litter and the lack of road drainage filtration along Carpenter Drain at County Road 200 West.

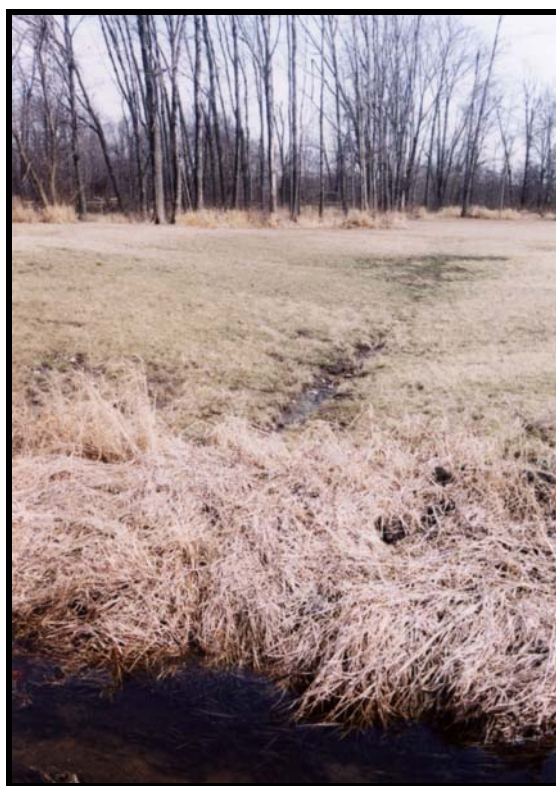
Figure 18. Potential wetland restoration site located adjacent to Carpenter Drain at Site C6.

C5	I-69 curb and gutter drainage system in disrepair	Work with the Indiana Department of Transportation (INDOT) to repair and/or replace current drainage system
C6	Historic wetland (Figure 18)	Potential wetland restoration site
C7	Road drainage/litter	Re-route water from road drainage into vegetated swale; initiate roadside litter clean-up program along tributaries
C8	Historic wetland	Potential wetland restoration site
C9	Residential area drainage pipe	Explore filtering options
C10	Historic wetland	Potential wetland restoration site
C11	Historic wetland	Potential wetland restoration site
C12	Historic wetland	Potential wetland restoration site
